ISM+D Institute of Structural Mechanics and Design Institut für Statik und Konstruktion

BACKGROUND

The project "Emergency Shelters Made of Paper" funded by ZukunftBau involved the development of a prototype paper shell with integrated measuring sensors. The roof, floor and walls were fully made of paper while the open gable walls were closed by polystyrene. The prototype was tested over a time period of six months under real weather conditions. In February of 2022, the prototype was severely damaged by a fire, making further monitoring impossible. A subsequent utilization concept was developed for the components that survived the fire with the aim of completing the project with the knowledge gained despite the unfortunate circumstances.

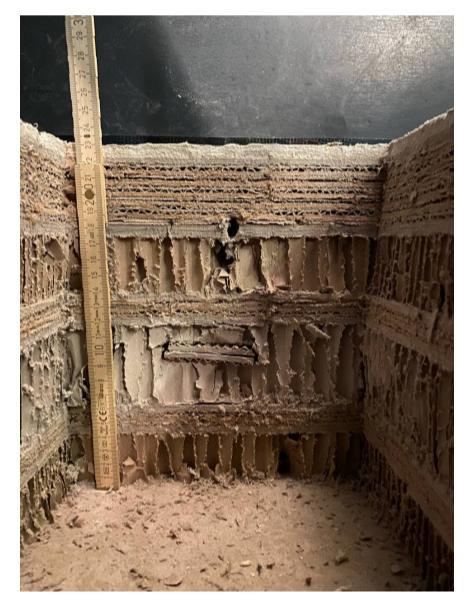
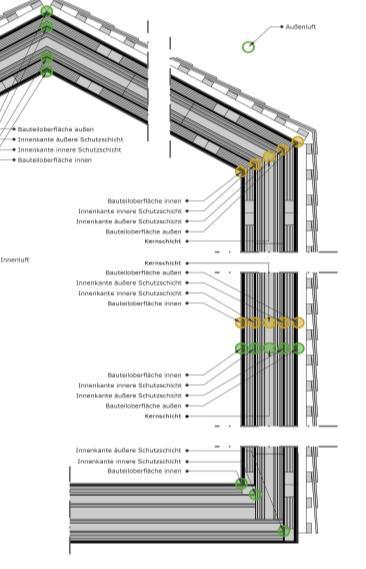
Floor component opening (left), position of the measurement sensors (right). TUDa 2023.

As part of the monitoring process, sensors for measuring temperature and humidity were integrated into various areas of the cross-section of the paper shell. The tests which were carried out over a timeframe of six months evaluating the humidity revealed that the diffusion density of the paper cover was insufficient. Nevertheless, moisture transport through the building envelope could be observed. The critical threshold values for moisture were not exceeded. At the beginning of 2022, a measurement cycle of around one week was carried out to evaluate the insulation effect. This resulted in reference points for optimizing the experimental setup.

The infrared lamp used for heating caused distortions in the recorded measurements which affected the sensors inside the wall. Due to the fire, no further measurement cycles could be recorded. The gained knowledge can therefore only be interpreted as initial indications of the behavior of a paper envelope under environmental influences.

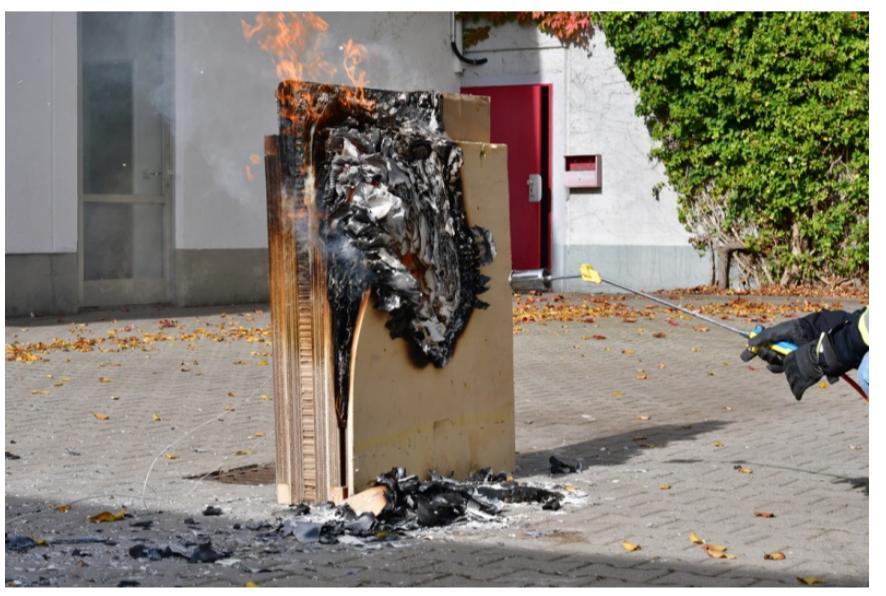
Test to determine the fire behaviour of a wall element. TUDa 2023.

Additionally, a structure was tested in which an entire cross-section was analyzed. The test results showed that the roof construction is the weakest point of the structure. The fire behavior of the construction was tested with a gas flame at 900 °C. The results reveal that constant flaming over 45 minutes was required to ignite a hole in the construction. The moisture tests showed that only the first layers of paper were affected by moisture under the usual dynamic pressure on facades. No critical value of 14% material moisture was exceeded. Moreover, the construction had an additional outer layer of polyethylene-sealed shingles as a rain barrier. The use of paper layers behind curtain-type, rear-ventilated facades can be assessed as positive in terms of rain resistance.

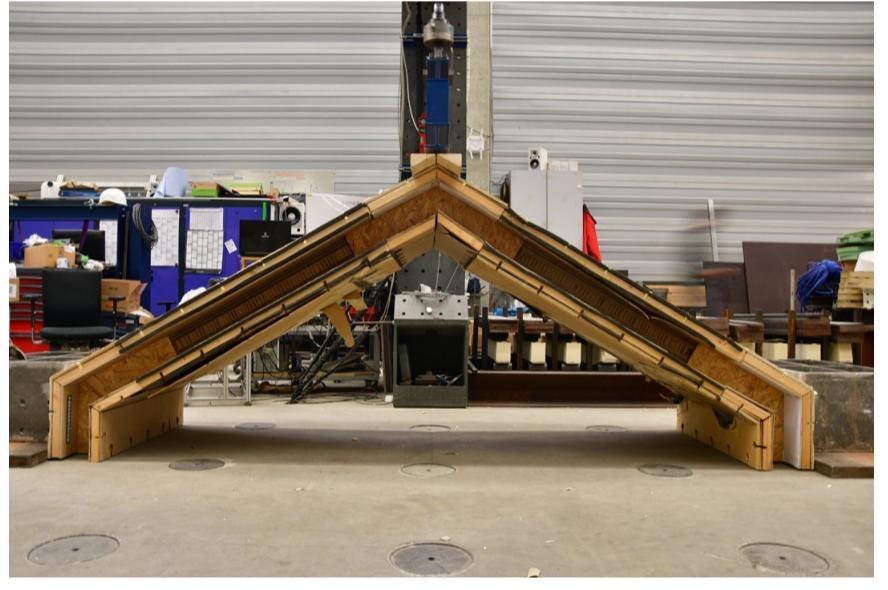
Load test of the roof cross-section. TUDa 2023
